The Deanery, Block 1 - External Façade Report

29 – 36 Carpathia Drive
37 – 55 Carpathia Drive
56 – 67 Carpathia Drive

October 2020

Report Number – JL/191020

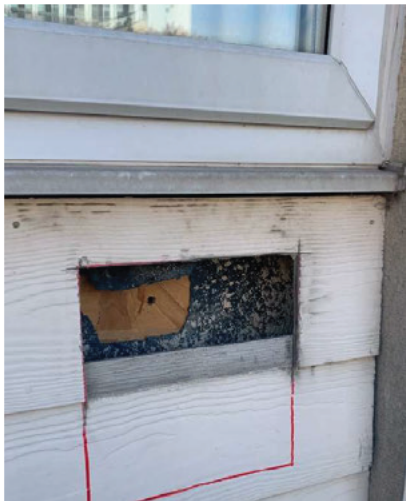
Area one was an intrusive investigation into the lapped cladding between two windows on the west elevation. The lapped cladding appears to be formed from a profiled fibrous board lapped to each other horizontally and are fastened using self-drilling screws. The cladding is installed to an internal timber frame constructed using horizontal and timber battens. There is a 95mm un-insulated cavity. There is a 12mm timber OSB board used as a sheathing board with a breather membrane to the face. Behind the sheathing board is a 100mm cavity filled with a mineral wool insulation. We did observe any cavity barriers or fire breaks in this location.

View of inspection location

Inspection recommendations to follow on receipt of fire engineers' findings and completed EWS1 form.

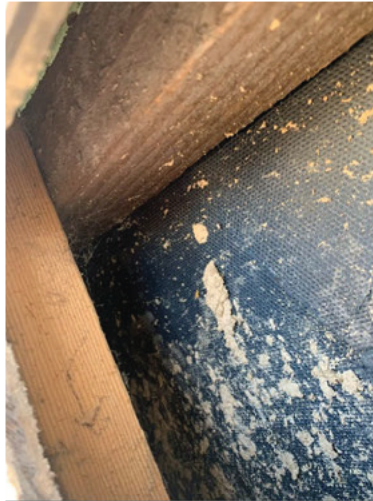
View of timber frame behind fibre board plank system

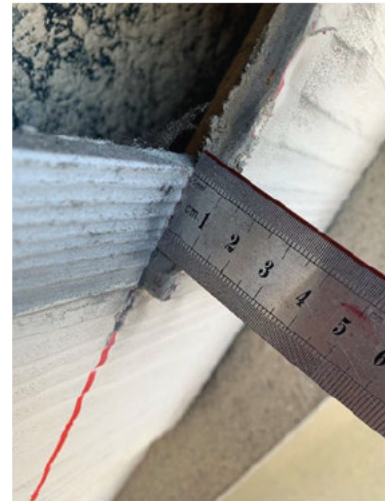
View of edge of fibre board plank system

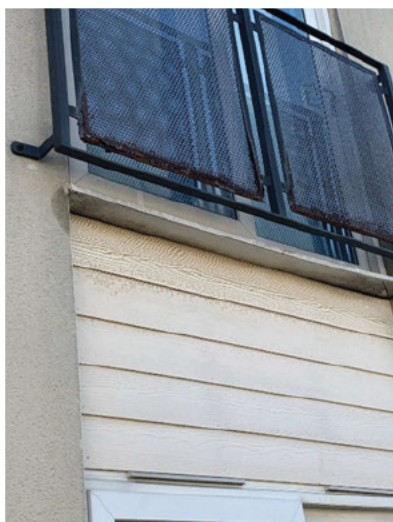
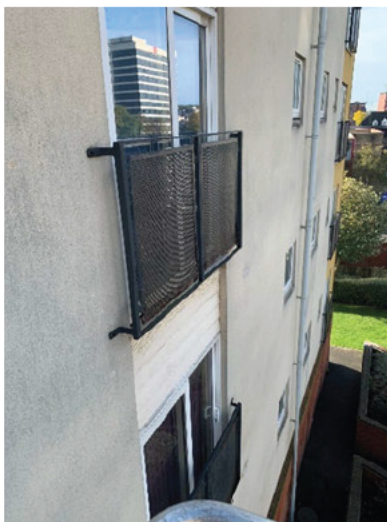
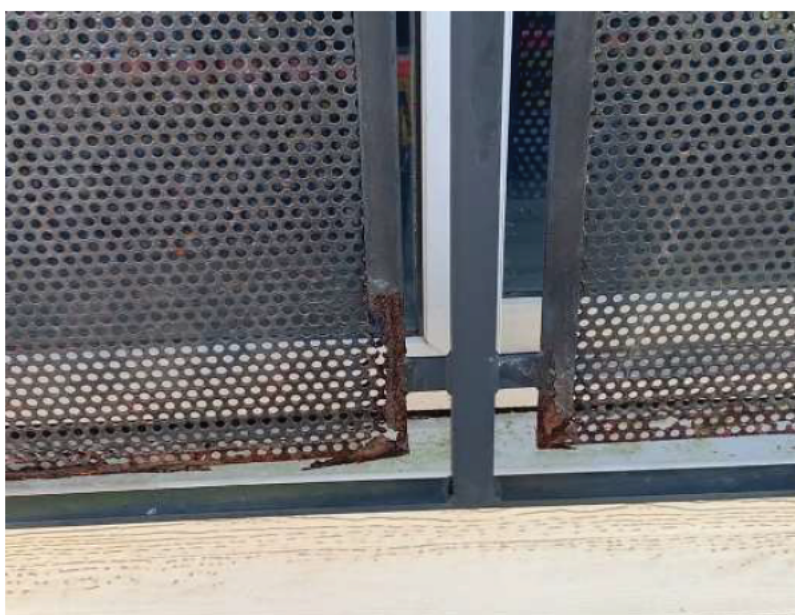
Area two was a visual inspection of the Juliet balconies on the west elevation. The balconies are constructed entirely from powder coated steel. The steel frames have been fixed back to the masonry using concrete anchor bolts. The balcony viewed in this location was in poor condition, with a considerable amount of oxidisation to the steel frame.

Inspection recommendations to follow on receipt of fire engineers' findings and completed EWS1 form.

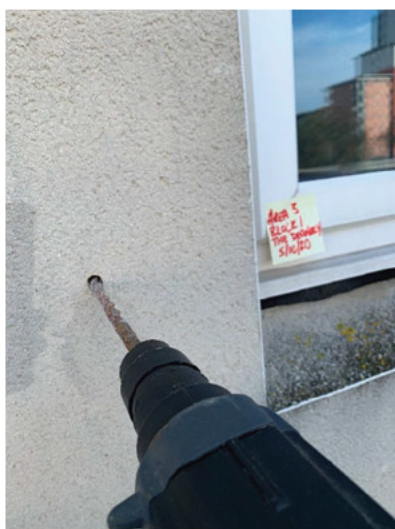
Area three was a drill test to the render façade on the west elevation adjacent to a window. A 10mm hole was drilled in the face of the render cladding and an endoscope used to view the internal build up. The render is applied directly to a blockwork outer wall. There is a timber frame and OSB board behind the external blockwork with a breather membrane and mineral wool insulation behind the OSB board. We did not witness any cavity barriers or fire breaks in this location.

View of inspection location

Inspection recommendations to follow on receipt of fire engineers' findings and completed EWS1 form.

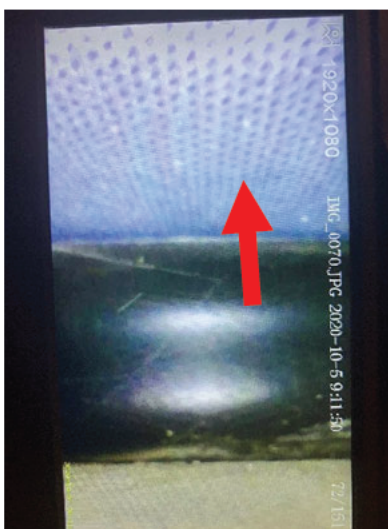
Endoscope view of cavity behind blockwork with breather membrane to OSB board

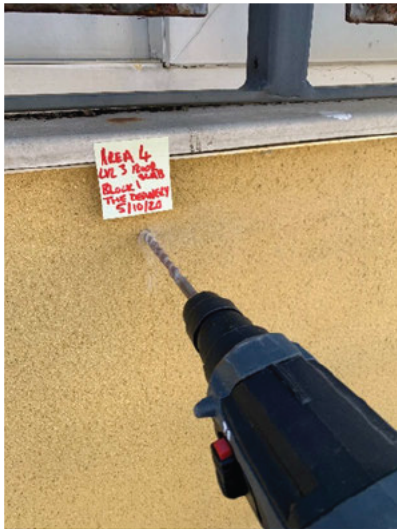
Area four was a drill test to the darker render on the west elevation below a window. A 10mm hole was drilled in the face of the render and an endoscope was used to view the internal build up. The render is applied directly to a blockwork outer wall. There is a timber frame and OSB board behind the external blockwork with a breather membrane and mineral wool insulation behind the OSB board. We did not witness any cavity barriers or fire breaks in this location.

View of inspection location

Inspection recommendations to follow on receipt of fire engineers' findings and completed EWS1 form.

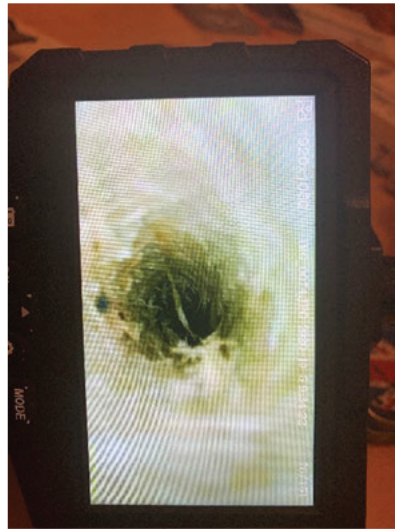
Endoscope view of mineral wool insulation

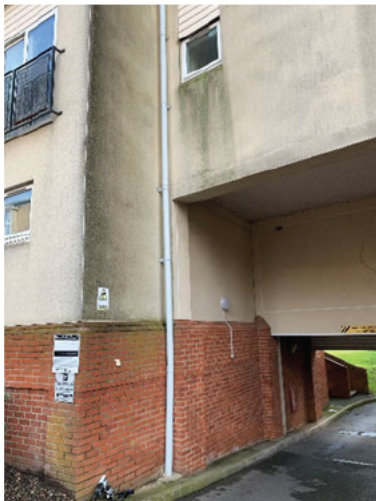
Area five was a drill test to the brickwork on the ground floor, west elevation. A 10mm hole was drilled in the face of the brickwork and an endoscope was used to view the internal build up. The outer wall is constructed from 100mm thick traditional red brick. There is a 70mm un-insulated cavity behind the brick and an inner wall formed from concrete blockwork. We did not observe any cavity barriers or fire breaks in this location.

View of inspection location

Inspection recommendations to follow on receipt of fire engineers' findings and completed EWS1 form.

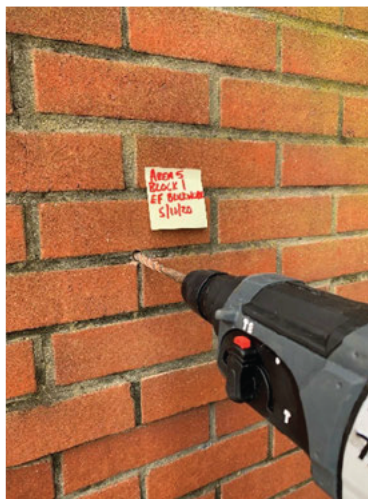
View of drill to location
