Vanguard Court (Eastney) Limited - 1-8 Vanguard Court

TYPE 1 FIRE RISK ASSESSMENT

09/11/2023

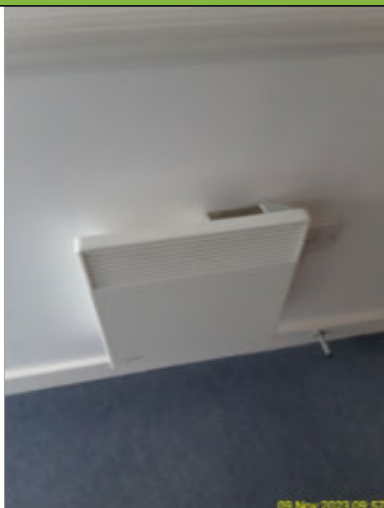
REF: 10.4

10.3	Are fixed heating installations subject to regular maintenance & testing?	N/A	No fixed heating systems were observed.
10.4	Are electric wall heaters fitted on site suitably maintained?	Yes	Electric wall heaters were identified linked to the electrical system via fixed fused spurs. The Responsible Person has confirmed that these are maintained in accordance with [REDACTED] policies and 18th Edition IET Wiring Regulations BS 7671:2018, however, the wall heaters should be included in the cleaning schedule and subjected to cleaning twice per year, once before winter and once after winter.

Are electric wall heaters fitted on site suitably maintained?

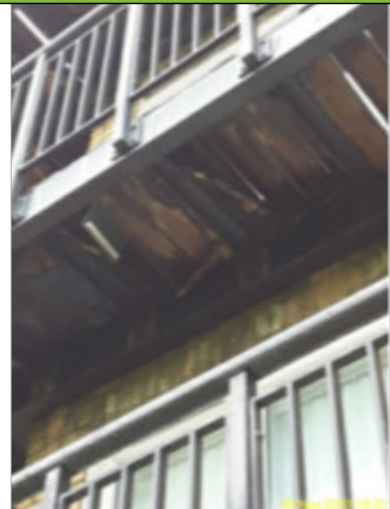
REF: 16.9

16.9	<p>Overall risk rating from balconies and/or external walkways?</p>	Tolerable	<p>It was noted that the decking and the underside of the protruding balconies which is plywood, were in a poor condition. ██████████ was informed by a ██████████ that the balconies were out of bounds and were not to be used until a planned works program was completed.</p> <p>██████████ Also see details above in section 16.3 and below in section 19.1 and associated action plan.</p> <p>Once remediation has taken place, provided sensible management of the balconies is undertaken, it is assessed that the risk to life safety from external fire spread via the balconies should be low. The most up to date RMG safety information posters should be displayed which provide information on balcony safety (see Section 31 for further details).</p>

Overall risk rating from balconies and/or external walkways?

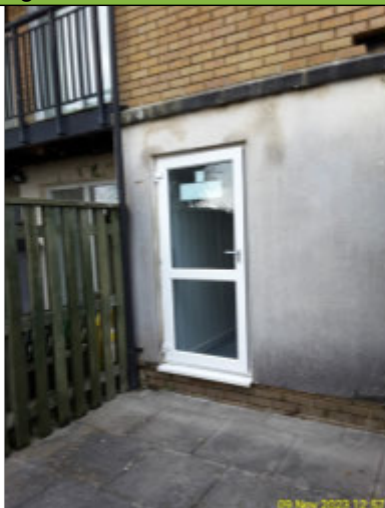
REF: 18.12

18.12	Are external escape routes in good condition, well lit, adequately signed and free from obstruction. (including metal escape stairwells, exits over flat roof, exits through another building etc.)	No	The block has a rear escape route, the route is out of the rear door and across the back of the building to a place of safety. It was identified that there is no lighting in the external escape route. This could lead to slip, trip or fall injuries to persons trying to escape in an emergency situation. Note: This external escape route is also used by adjoining block. Additionally, there is a timber gate which has to be passed through to make an escape. This gate was found to be in poor condition and jammed in the frame making it difficult to open. The gate was also fitted with sliding bolt fixings which is an unsuitable way of fastening gates in this situation.

Are external escape routes in good condition, well lit, adequately signed and free from obstruction.

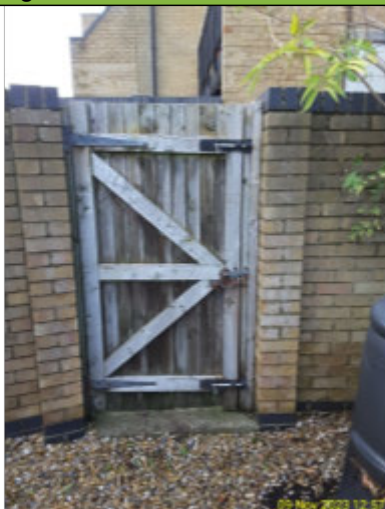
REF: 18.12

Are external escape routes in good condition, well lit, adequately signed and free from obstruction.

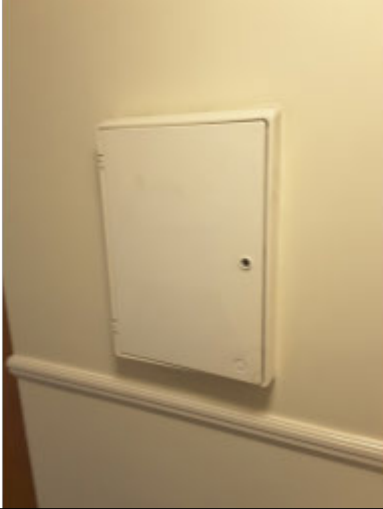
REF: 19.4

19.4	Is it considered that there is compartmentation of a reasonable standard within the escape routes?	No	A number of the individual plastic meter cupboards and supply boxes were checked, and they were found to have holes and gaps where cables have been routed which have not been or have been fire stopped with PU foam. These breaches may could allow for fire to spread internally within the fabric of the building. Additionally, as the covers may not be fire rated, they could fail in the early stages of a fire and compromise the MOE. Although it is assumed that these cupboards are demised to the resident and not under the responsibility of the managing agents, these cupboards could have a significant effect on the safety of residents, especially as they open onto a single stair (means of escape).

Is it considered that there is compartmentation of a reasonable standard within the escape routes?

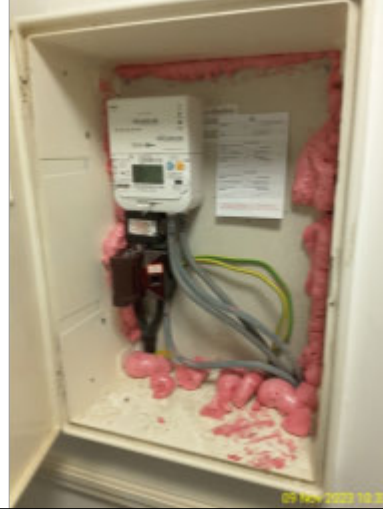
REF: 19.4

Is it considered that there is compartmentation of a reasonable standard within the escape routes?

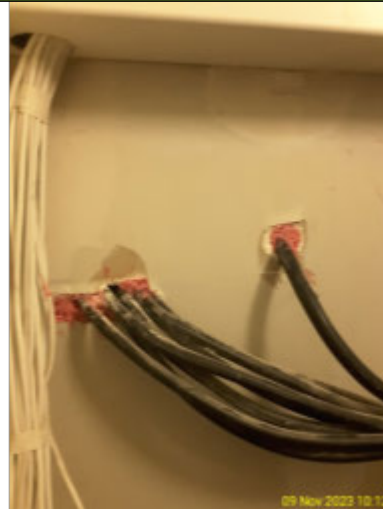
REF: 19.3

19.3	Is it considered that there is compartmentation of a reasonable standard within service cupboards and riser shafts?	No	It was noted that in the service cupboards, fire breaches have been sealed using excessive PU foam. PU foam of any type should not be used next to cables, pipework, or timber. In the event of fire in the service areas the foam will fail, and fire will spread to the fabric of the building and may spread throughout the block.

Is it considered that there is compartmentation of a reasonable standard within service cupboards and riser shafts?

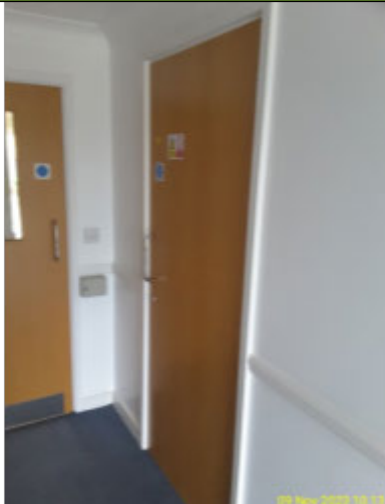
REF: 19.7

19.7	Are service cupboard fire doors suitable and in good condition? including service and riser cupboard doors	Yes	The service cupboard communal fire doors throughout were examined and found to be to FD30s standard, in good order, and fully fitted with cold smoke seals and intumescent strips.

Are service cupboard fire doors suitable and in good condition?

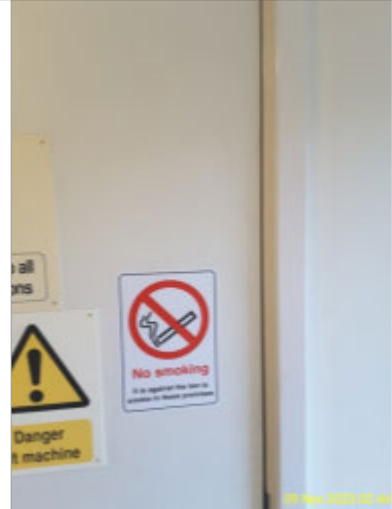
REF: 21.2

21.2	Are "Fire Door - Keep Locked" signs in place where required?	Yes	The lift machinery room fire door is missing a "Fire door keep locked" signs. Fitted [REDACTED] during inspection.

Are "Fire Door - Keep Locked" signs in place where required?

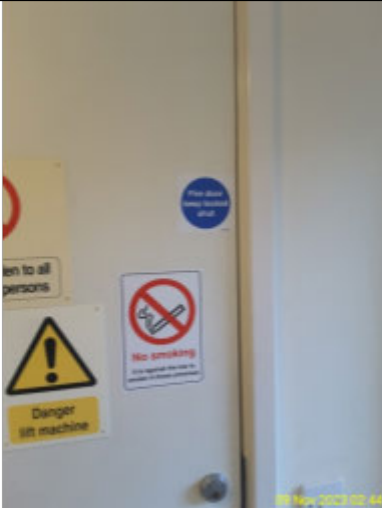
REF: 21.2

Are "Fire Door - Keep Locked" signs in place where required?

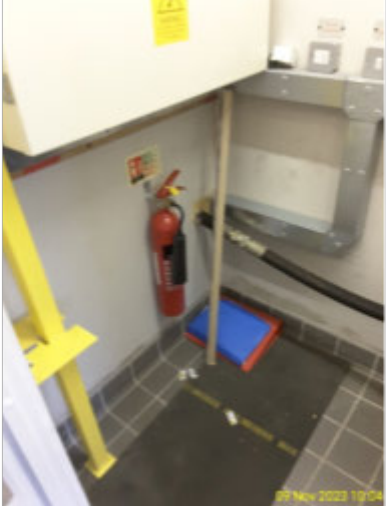
REF: 23.1

Ref	Item	Answer	Comments
23.1	Is reasonable provision of manual fire extinguishing appliances in place? (Including extinguishers and hose reels)	Yes	CO2 fire extinguishers were noted in the plant room.

Is reasonable provision of manual fire extinguishing appliances in place?
