The Deanery, Block 1 - External Façade Report

29 – 36 Carpathia Drive
37 – 55 Carpathia Drive
56 – 67 Carpathia Drive

October 2020

Report Number – JL/191020

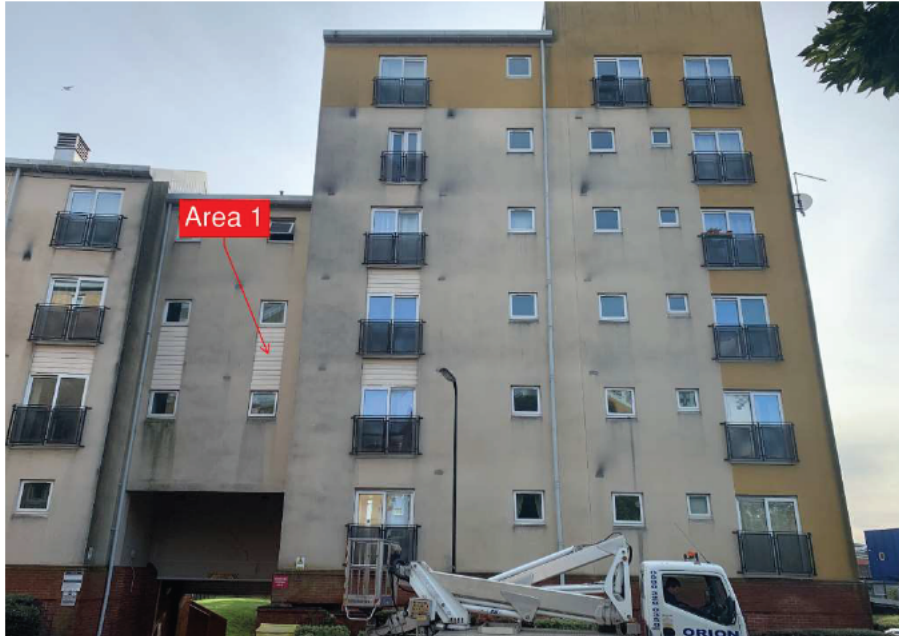
Area 1

Area one was an intrusive investigation into the lapped cladding between two windows on the west elevation. The lapped cladding appears to be formed from a profiled fibrous board lapped to each other horizontally and are fastened using self-drilling screws. The cladding is installed to an internal timber frame constructed using horizontal and timber battens. There is a 95mm un-insulated cavity. There is a 12mm timber OSB board used as a sheathing board with a breather membrane to the face. Behind the sheathing board is a 100mm cavity filled with a mineral wool insulation. We did observe any cavity barriers or fire breaks in this location.

Inspection recommendations to follow on receipt of fire engineers' findings and completed EWS1 form.

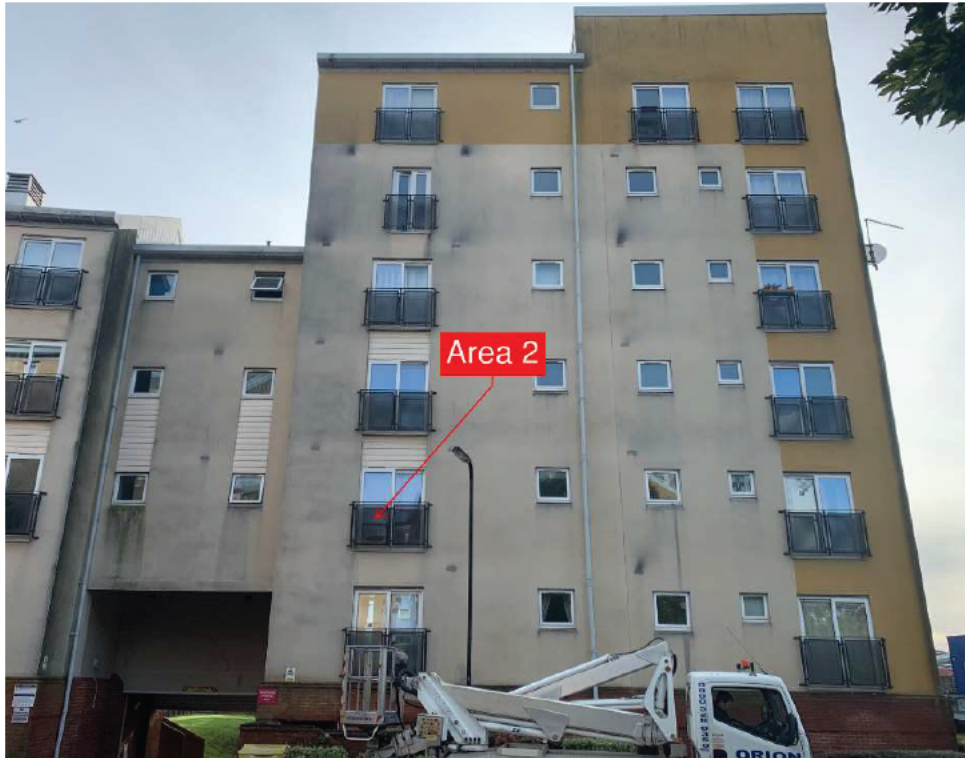
Area 2

Area two was a visual inspection of the Juliet balconies on the west elevation. The balconies are constructed entirely from powder coated steel. The steel frames have been fixed back to the masonry using concrete anchor bolts. The balcony viewed in this location was in poor condition, with a considerable amount of oxidisation to the steel frame.

Inspection recommendations to follow on receipt of fire engineers' findings and completed EWS1 form.

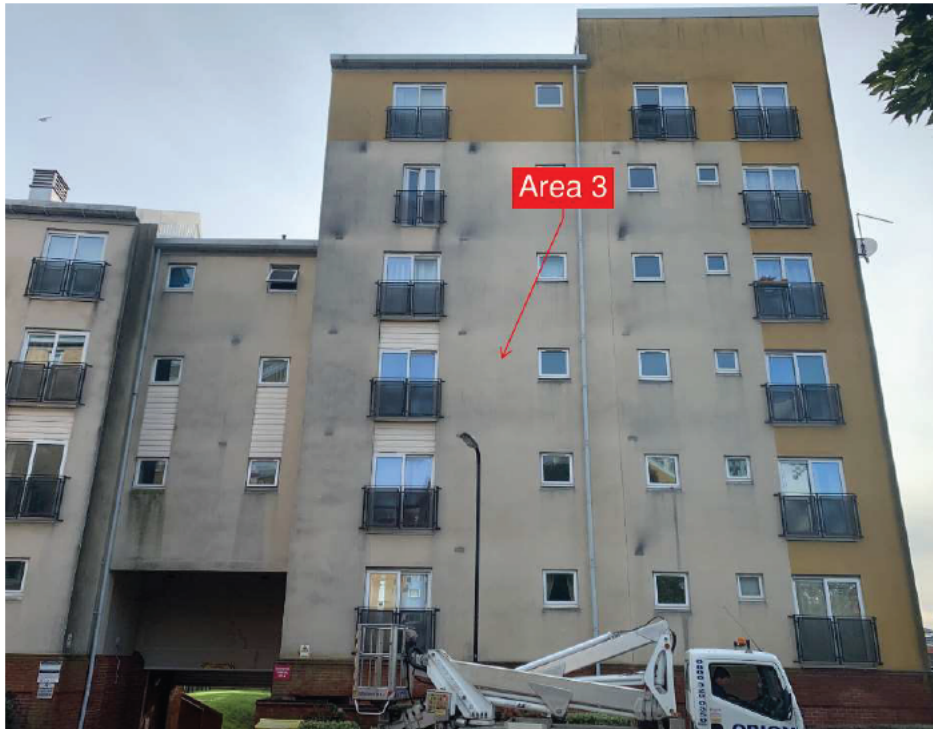
Area 3

Area three was a drill test to the render façade on the west elevation adjacent to a window. A 10mm hole was drilled in the face of the render cladding and an endoscope used to view the internal build up. The render is applied directly to a blockwork outer wall. There is a timber frame and OSB board behind the external blockwork with a breather membrane and mineral wool insulation behind the OSB board. We did not witness any cavity barriers or fire breaks in this location.

Inspection recommendations to follow on receipt of fire engineers' findings and completed EWS1 form.

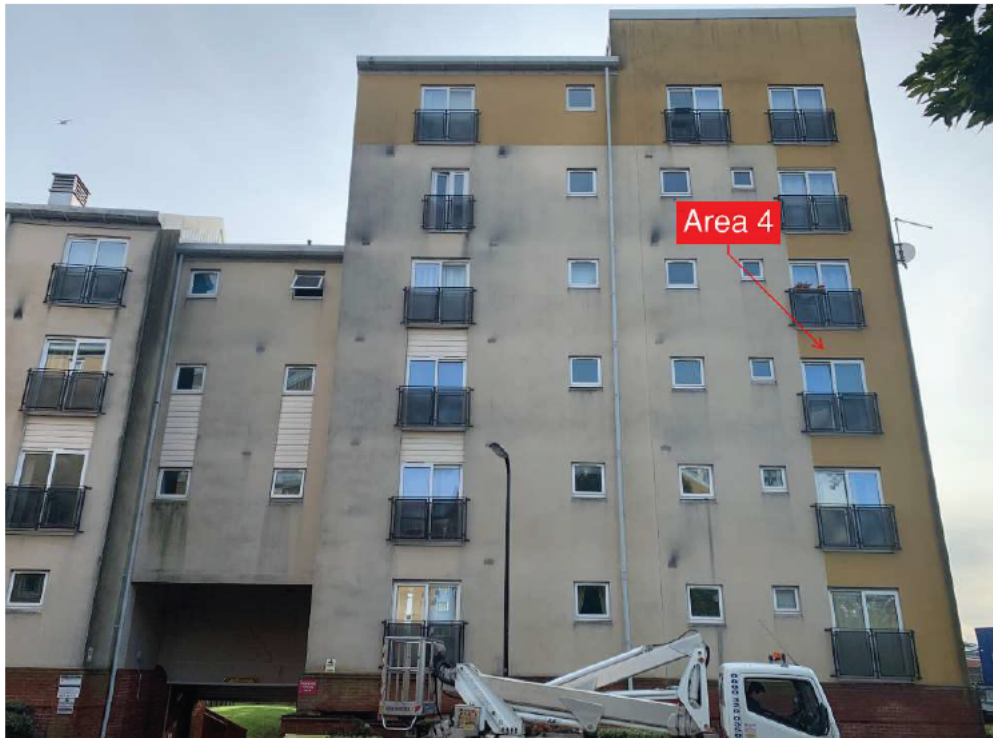
Area 4

Area four was a drill test to the darker render on the west elevation below a window. A 10mm hole was drilled in the face of the render and an endoscope was used to view the internal build up. The render is applied directly to a blockwork outer wall. There is a timber frame and OSB board behind the external blockwork with a breather membrane and mineral wool insulation behind the OSB board. We did not witness any cavity barriers or fire breaks in this location.

Inspection recommendations to follow on receipt of fire engineers' findings and completed EWS1 form.

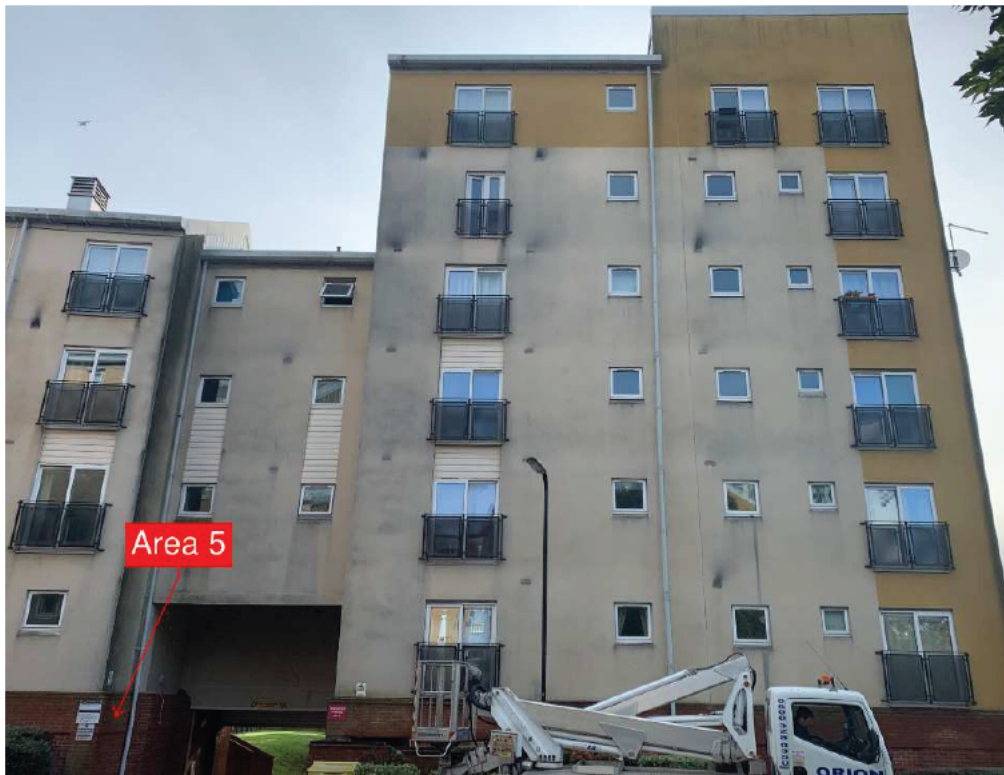
Area 5

Area five was a drill test to the brickwork on the ground floor, west elevation. A 10mm hole was drilled in the face of the brickwork and an endoscope was used to view the internal build up. The outer wall is constructed from 100mm thick traditional red brick. There is a 70mm un-insulated cavity behind the brick and an inner wall formed from concrete blockwork. We did not observe any cavity barriers or fire breaks in this location.

Inspection recommendations to follow on receipt of fire engineers' findings and completed EWS1 form.
