## **SCHEDULE OF CONDITION**

**TOP SPOT SNOOKER CLUB  
37B PARK PARADE  
LEIGH PARK  
HAVANT  
HAMPSHIRE PO9 5AA**

**Prepared by:** Eddisons incorporating Daniells Harrison  
The Old Manor House, Wickham Road  
Fareham, Hampshire, PO16 7AR  
Tel: 01329 221199 or 01329 557540

**Date of Inspection:** Tuesday 18<sup>th</sup> April 2023

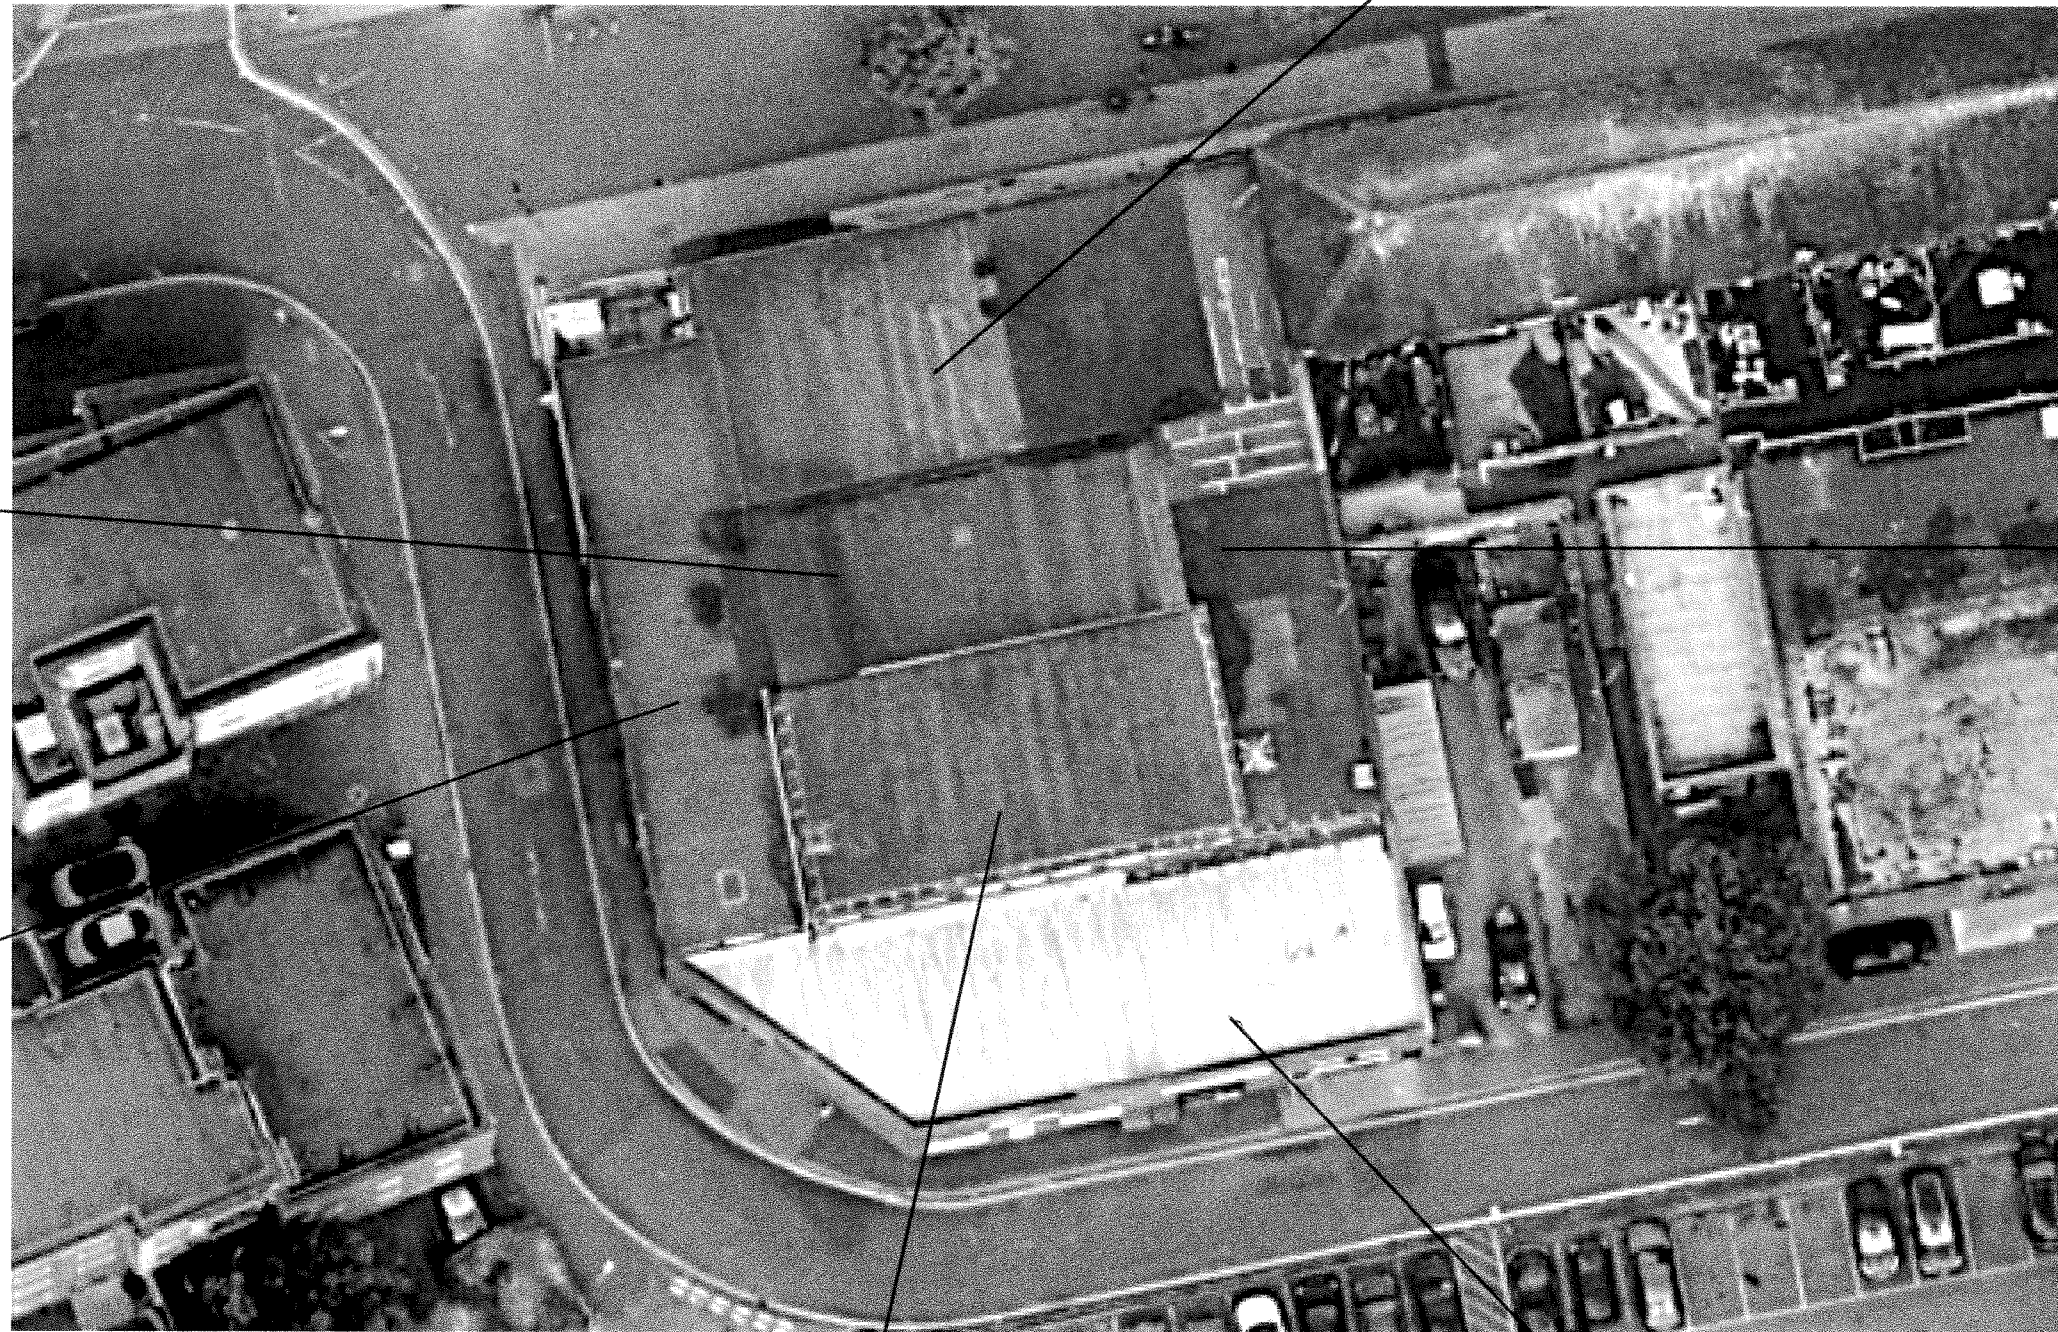
INDICATIVE ROOF AREAS - EXTERNAL.

HIGH LEVEL ROOF -  
CENTRE PANEL (REAR)

HIGH LEVEL ROOF  
- CENTRE PANEL  
(MIDDLE)

LOWER SECTION  
TO RIGHT (EAST)
